STREAMLINING TANK INSPECTIONS WITH VISUAL FEEDBACK

Optically activated pigments highlight areas in need of repair, explain Justin Hair and Michael Harrison from Sherwin-Williams Protective & Marine

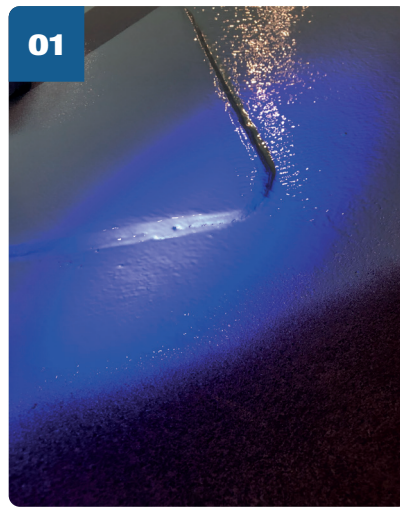
- 01** Optically activated pigments (OAPs) embedded in this single-coat lining system featuring Sherwin-Williams Opti-Check technology provide a distinct visual indication of a pinhole and some coating discontinuities in the weld seam
- 02** When inspecting single-coat linings featuring OAPs, dark areas will indicate coating deficiencies. The rest of the coated areas will fluoresce
- 03** In this two-coat system, OAPs embedded in the base coat shine through the topcoat and appear pink under UV light (right), indicating a pinhole and some thin areas that will need to be repaired
