ANSWER TO THE CORROSION CONUNDRUM?

Bruce Toews (USA), Neil Wilds (UK), and Johnny C. Pourciau (USA), Sherwin-Williams Protective & Marine, look

at how coating additives can enhance corrosion protection before and during service.

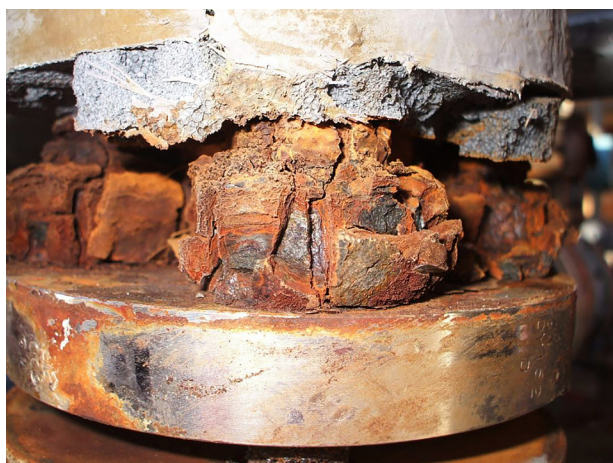
Figure 1. CUI is inevitable over time as moisture and contaminants get trapped under insulation on LNG pipes, storage tanks, and process vessels and face thermal cycling.

Protective coatings applied beneath insulation on pipes, valves, tanks, and other downstream assets used in LNG operations are important tools in mitigating the troublesome and potentially dangerous phenomenon of corrosion under insulation (CUI) (Figure 1). However, most coatings are not up to the task – especially those without sufficient film builds and reinforced additives – and are prone to premature deterioration under insulation. The problem comes when moisture mixed with contaminants penetrates and then saturates the insulation. Trapped inside and subject to elevated temperatures, the water and contaminants can initiate the development of corrosion cells that eat away at coatings, thus threatening the covered asset. CUI can be especially prevalent in the bends, flanges, and elbows of insulated pipework transporting LNG byproducts, the undersides of pressure vessels within LNG process trains, and the lower areas of ground LNG storage tanks – all areas where moisture collects due to gravity.

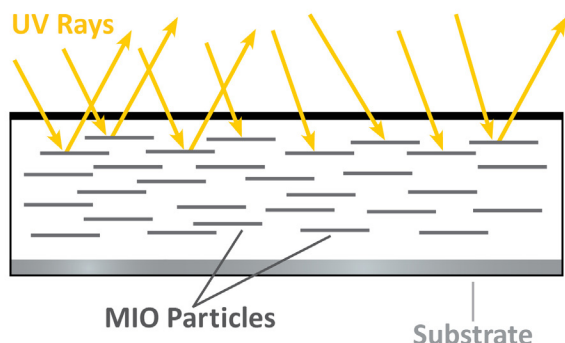
Figure 2. MIO pigments embedded in a coating form a barrier that deflects UV rays to minimise degradation of the coating. The layered pigment structure also mitigates the penetration of moisture, oxygen, and other elements into the coating.

The coatings industry is finding that certain linings that are effective in immersion environments also work best in mitigating CUI, since CUI occurs in immersion-like conditions. Such coatings contain flakes of natural MIO pigment. Lab experiments have shown that MIO flakes form a layered barrier that deflects UV rays to minimise degradation of the coating (Figure 2). This layering also mitigates the penetration of moisture, oxygen, and other elements into the coating, while increasing the coating's durability against impacts and chemicals. In addition, MIO flakes withstand high temperatures until reaching their melting point of 1500°C. That is important because insulated assets are often exposed to extreme heat.

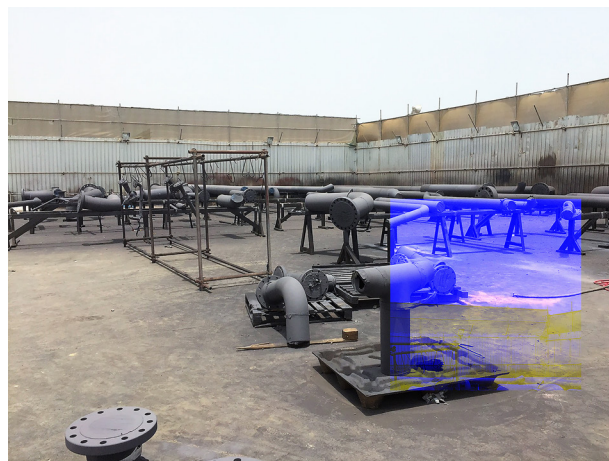
Figure 3. Applying IMM coatings embedded with MIO to process vessels, pipes, and valves in LNG operations can effectively protect those assets from damage and corrosion prior to service, as well as mitigate the effects of CUI when assets are later insulated and placed into service.

Inert multipolymeric matrix IMM coatings are ideal for insulated pipes, valves, and process vessels housing LNG byproducts and operating at extremely high temperatures where thermal shock can occur (Figure 3). The IMM material that underwent tests was designed to handle temperatures ranging from cryogenic levels to 649°C (1200°F). It is the hardest silicone coating in the petrochemical industry, but it also expands and contracts, like the asset underneath, so it can survive thermal fluctuations. Comparatively, epoxy coatings may turn brittle and crack from thermal shock.

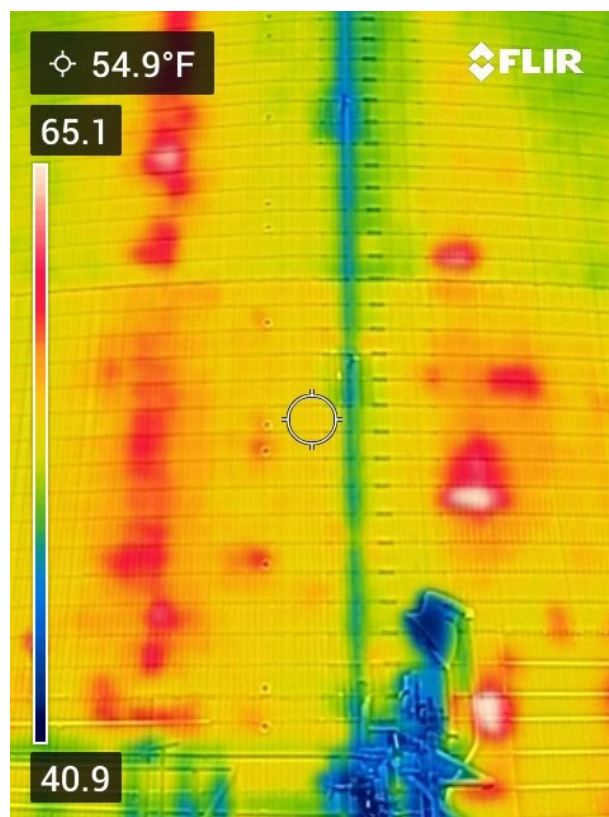
Figure 4. Forward looking infrared (FLIR) imaging inspections of this ground storage tank reveal areas of concern for CUI, with the red areas indicating areas of excessive heat loss.

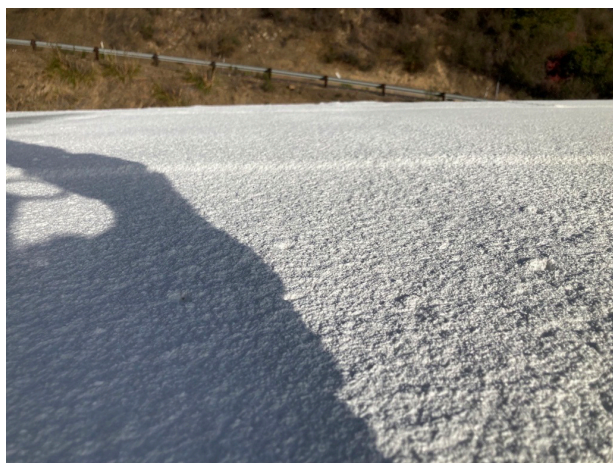
Figure 5. A new insulative coating (shown here without a topcoat) poised to launch in 2022 is applied up to 10 mm DFT in two coats to retain sufficient heat in pipes and vessels, like this ground storage tank, such that traditional insulation systems are not needed.

The new coating is based on existing products that have already battled CUI, but it is far superior. The coating is applied much thicker than any other now on the market, up to 10 mm DFT in two coats, plus a topcoat to seal and smooth the finish. At that thickness, the coating retains heat similarly to traditional insulation, as proven in forward looking infrared (FLIR) imaging taken on a ground storage tank being tested with the coating. The coating creates a monolithic barrier that bonds to the surface of the asset, leaving no gap or corrosion zone for moisture to get close to the substrate. Further, the coating's thermal performance will not reduce over time unlike when traditional insulation becomes laden with moisture.

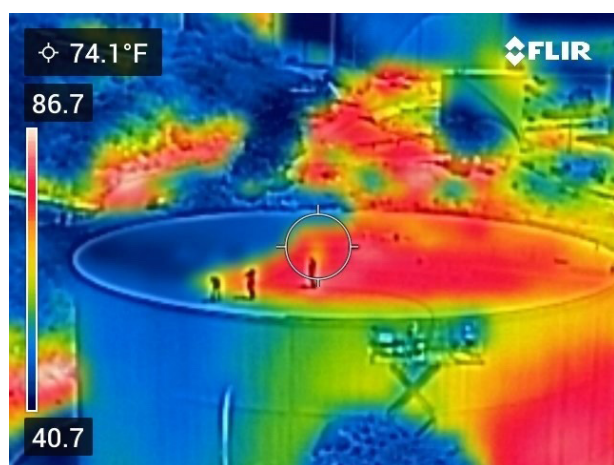
Figure 6. FLIR imaging of this ground storage tank being covered with a new insulative coating demonstrates how well the coated areas (blue and green) retain heat compared to the non-coated areas (red and yellow).
