SAFEGUARDING THE WATER SUPPLY — BREATHING NEW LIFE INTO DAYTONA BEACH'S TREATMENT PLANT

Extensive Concrete Restoration and Advanced Coatings Play Central Role in Modernizing the Ralph Brennan Water Treatment Plant

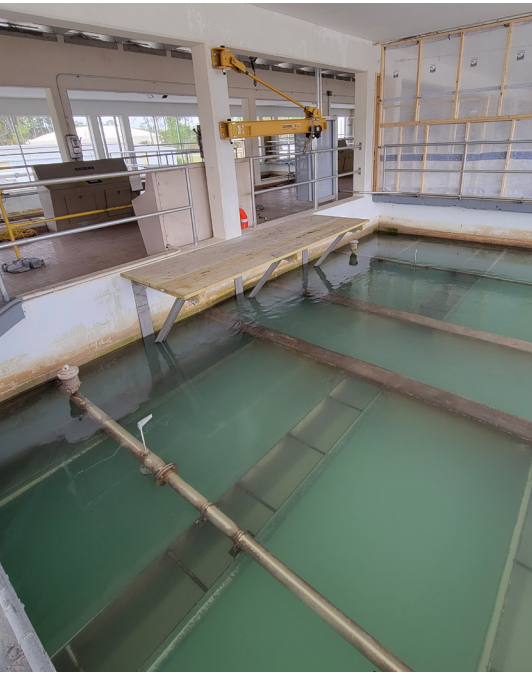
Figure 1. The project centered on rehabilitating six gravity filter basins with varied conditions and coatings, employing advanced methods to extend their life while reducing environmental impact.

At the heart of the project was the restoration of six gravity filter basins (Figure 1), each with unique conditions, including deteriorated concrete. The coatings also varied from thick epoxy layers — up to 125 mils — dating back 50 years, to thinner applications from the early 2000s.

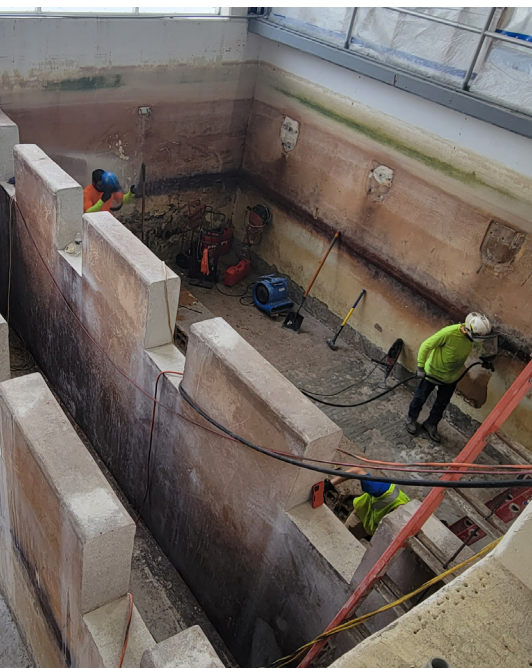
Figure 2. Crews stripped coatings to bare concrete using saw-cutting, chipping and blasting, followed by pressure washing to prepare the basins for resurfacing.

Crews used saw-cutting keyway lines, pneumatic chipping and scraping to strip coatings down to the bare concrete. Surface prep for these basins involved abrasive blasting with coal slag to achieve a concrete surface profile of 8-9, followed by 5,000-psi pressure washing to eliminate debris and prepare for resurfacing (Figure 2).

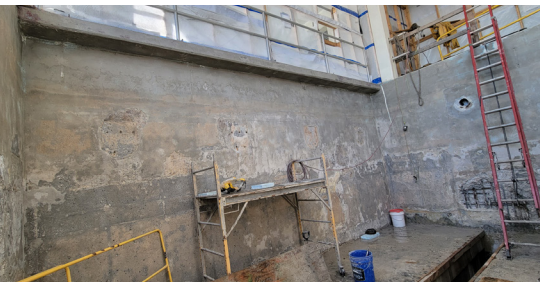
Figure 3. Crews used vertical mortars and cementitious materials to repair damaged areas and restore the original substrate profile.

For areas with significant substrate damage (Figure 3), crews employed vertical mortars and cementitious resurfacing materials to restore the original profile.

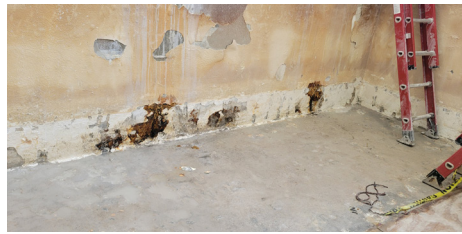
Figure 4. In newer basins with thinner coatings, surface grinding and rapid-cure mortars addressed high areas, exposed rebar and deeper damage.

In the newer basins where coatings were thinner — about 20 to 30 mils — less aggressive methods sufficed. Surface grinding smoothed high areas, while rapid-cure vertical mortars patched exposed rebar and deeper damage (Figure 4).

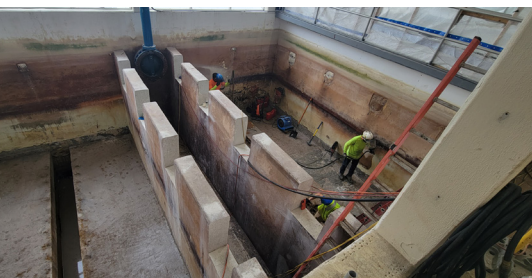
Figure 5. Applicators hand-applied Dura-Plate® 2300 at an average thickness of 3/16 inch, forming a durable base for the new coatings.

Applicators applied Sherwin-Williams Dura-Plate® 2300, a cementitious resurfacing material, by hand to an average thickness of 3/16 inch, creating a robust foundation for the new coatings (Figure 5).

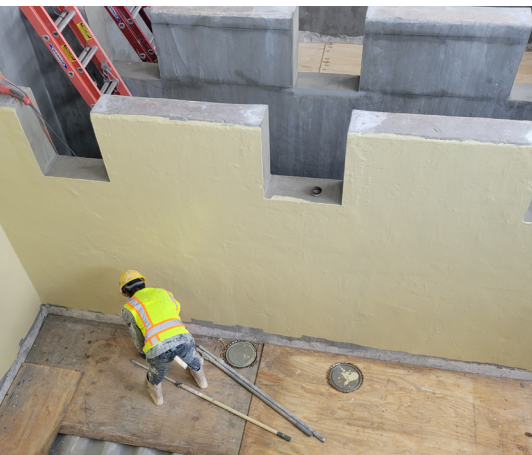
Figure 6. Final coatings included multiple layers of Macropoxy® 5500 for durability, with Pro Industrial™ epoxy applied on moisture-prone surfaces for breathable, uniform protection.

Final coatings included multiple layers of Macropoxy® 5500, applied to reach a thickness of approximately 20 mils dry film thickness (Figure 6). For moisture-prone concrete surfaces, crews selected Pro Industrial™, a catalyzed water-based epoxy chosen for its moisture resistance and breathability. Applied using an airless spray and backrolling technique, this system provides uniform protection against contaminants.

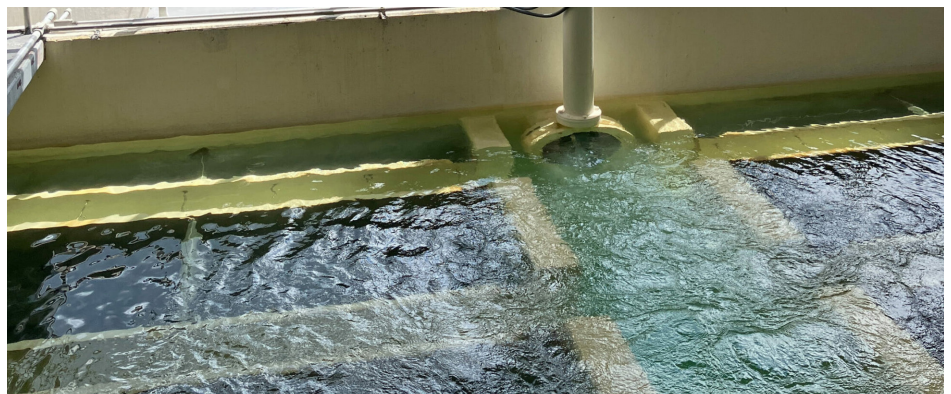
Figure 7. Each basin took about three weeks to return to service, including surface prep, equipment installation, filtration media setup and thorough holiday testing for coating flaws.

Each basin took around three weeks to bring back into service (Figure 7), including performing meticulous surface preparation, applying coating materials and installing mechanical equipment and filtration media. The team also performed rigorous holiday testing using high-voltage equipment to detect even the smallest coating flaws.

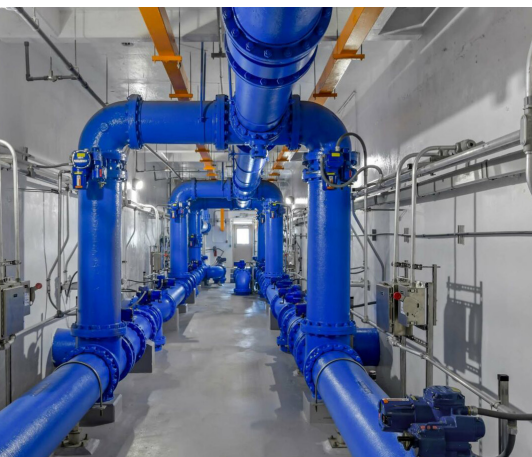
Figure 8. The rehab also included upgrades to the pipe gallery, where crews used high-pressure washing and electric bristle blasters to remove corrosion while protecting sensitive equipment.

The water treatment plant rehab also included significant upgrades to the facility's pipe gallery (Figure 8), where extensive corrosion had compromised equipment. Crews used a 5,000-psi rotator tip pressure wash and electric bristle blasters to address corroded areas without damaging nearby sensitive instrumentation.

Corroded areas were spot primed with Macropoxy® 920, followed by two coats of Macropoxy® 646 and a final layer of Acrolon™ 218. Stainless steel hardware replaced older, corroded components.

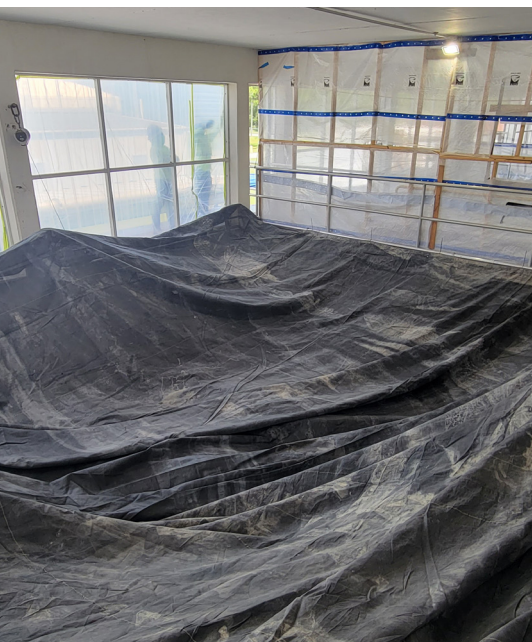
Figure 9. Custom containment structures were built around each basin to prevent contamination, with daily inspections for compliance.

Environmental and safety considerations were also central to the project. Custom-built containment structures surrounded each basin (Figure 9), as well as ancillary pipes and equipment, to prevent contamination and were inspected daily for compliance.
