# SHERWIN-WILLIAMS HIGH PERFORMANCE FLOORING NMP CHEMICAL RESISTANCE TESTING RESULTS

EV Battery Cell Manufacturing Plant in Ohio

ASTM D1308 Standard Test Method for Chemical Exposure on Coating Systems

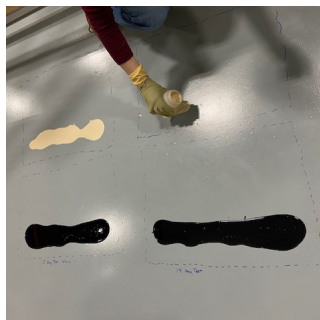
Both the insulation and slurry were applied to the floor and covered with both foil and plastic, then sealed with tape to prevent evaporation.

*Pouring, covering and sealing of the insulation and slurry*

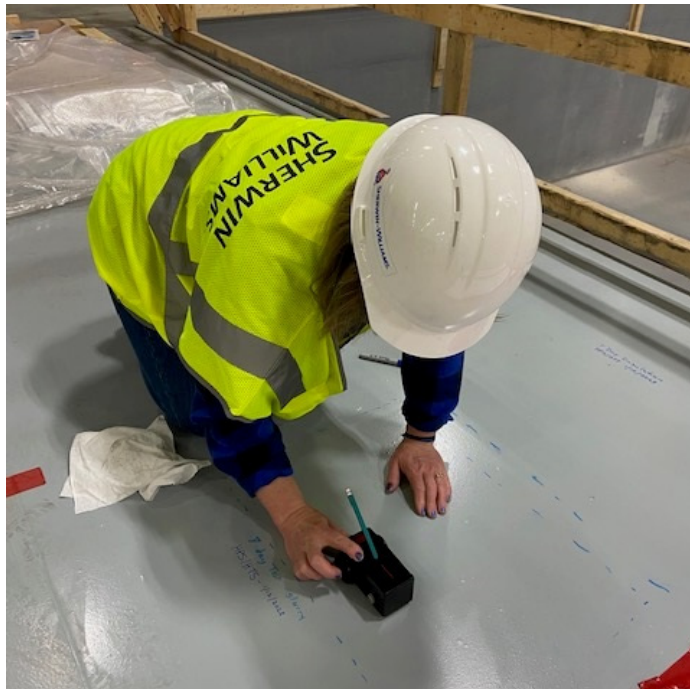
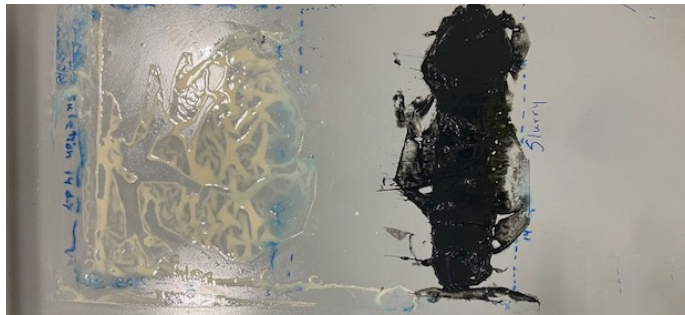
HTS System rated “Good” after 14-day exposure to both Insulation and Slurry. Slight change in satin appearance to slightly matte finish. Pencil Hardness 6H to 5H.

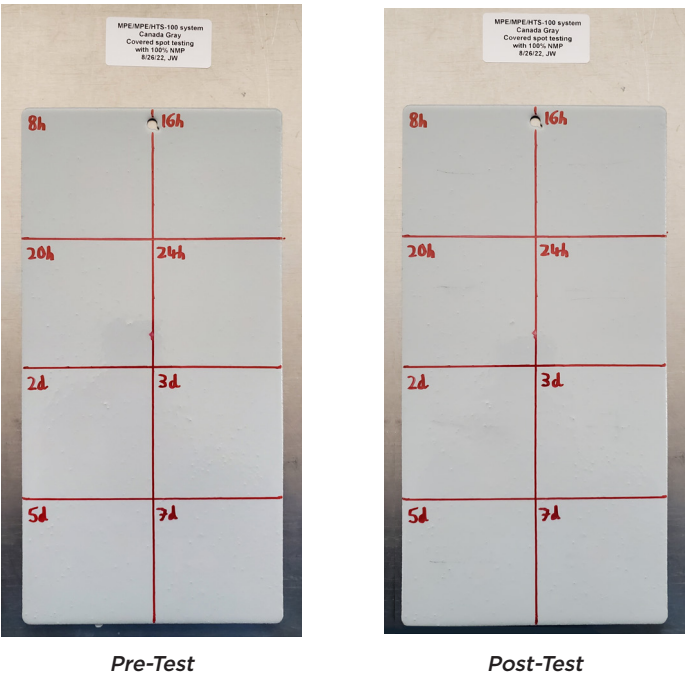
Pre-test and post-test panel after subjected to 100% NMP

**Results:** Little to no change reported. Panels look nearly identical.

| SYSTEM | 14-DAY EXPOSURE TO NEAT-NMP<br>(CURED AT 70°F/10% RH FOR TWO WEEKS) |
|---|---|
| Use combination of <b>Resutile HPS Clear</b> with <b>Topcoat of HTS Canada Gray</b> . Must have <b>HPS Clear</b> underneath <b>HTS Canada Gray</b> for maximum resistance to neat-NMP. | No change in hardness, slight color change (lighter), no other issues |
