SEALING THE SEAMS

How Resinous Coating Systems Help Food and Beverage Plants Restore Aging IMP Walls, Address Harborage Points and Simplify Maintenance Planning

By Feraas Alameh, Market Segment Manager, Food & Beverage, and Quintin McKenna, Asset Protection Manager, Manufacturing & Processing, Sherwin-Williams Protective & Marine

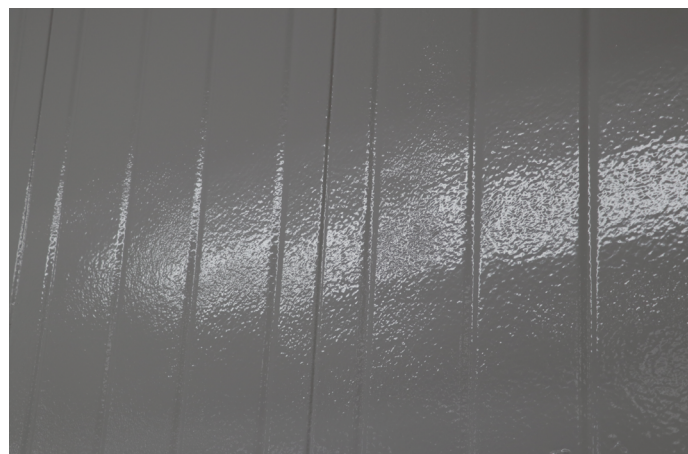
Figure 1. Close-up of an IMP wall surface after resinous coating application. The system bridges panel seams and creates a continuous, cleanable finish that reduces areas where moisture can collect.

It usually starts at the joints. Sealants used to plug those seams wear down. Along the way, panel surfaces may also get dented by carts and forklifts. Sanitation crews may wear through the factory-applied finish. Then, moisture and cleaning solutions are able to continue finding the same places to work their way into, causing further wear. What looks like routine wall wear can become something more consequential: a seam that holds moisture, a peeling patch coat or a damaged area that can no longer be sanitized the way it should (**Figure 1**).

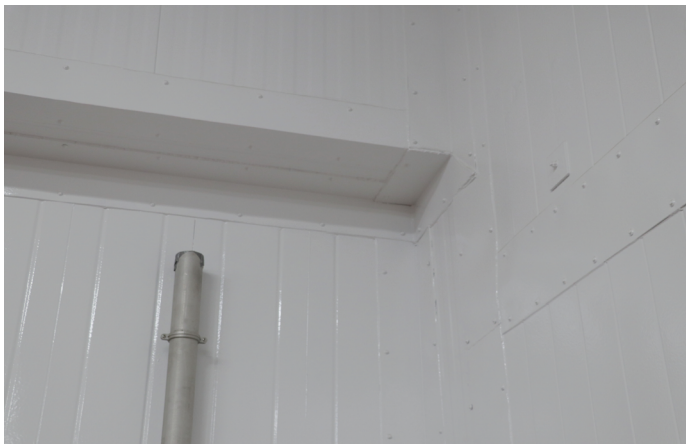
Figure 2. Detail view of a coated IMP wall showing how resinous systems can cover seams, corners and transitions with a more continuous finish. These areas are often the first places where conventional sealants and patch repairs begin to fail.

The joints between IMP walls are the other persistent problem. Every IMP seam depends on sealant to remain watertight. In active food plants, repeated washdown and chemical exposure work against that seal over time. Resealing every joint on a regular cadence is a significant maintenance burden, and in practice it often gets delayed. Once that happens, moisture has a path into exactly the kind of hidden area facilities are trying to avoid. Then, a panel joint becomes a harborage point (**Figure 2**).

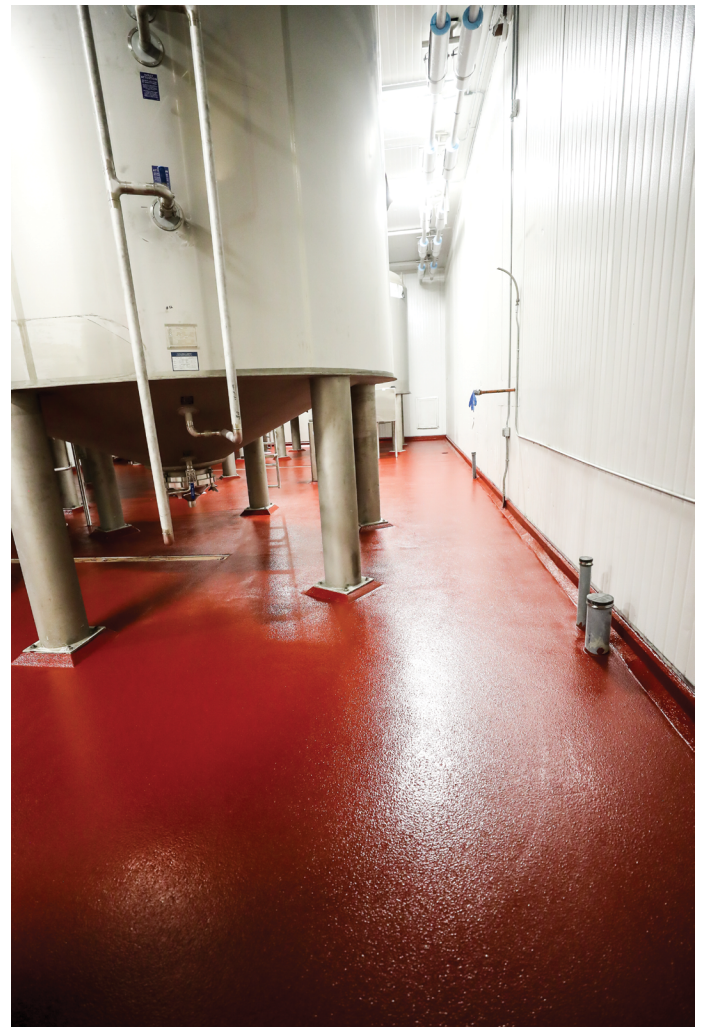
Figure 4. A food and beverage processing area showing a resinous floor system with a cove base transition to IMP walls. This type of interface would be assessed for cleaning access and moisture risk during a site evaluation.

At wall-to-floor transitions, the treatment depends on the existing layout. In most cases, the wall system terminates at the integral cove, with sealant applied from the wall down to the cove. Where a larger curb is present – two feet or more – the system can extend over the curb and tie into the floor for a more continuous transition. The goal either way is to eliminate vulnerable interfaces that collect moisture and resist cleaning (**Figure 4**).
