### **CASE STUDY**

# SOUTHWEST TRANSIT FLOOR RECEIVES RESILIENT RENOVATION

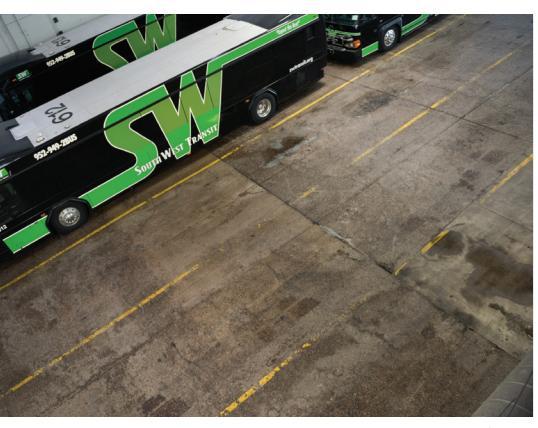
BEFORE

The staff of SouthWest Transit knew a year in advance that they had room in their budget for a partial floor replacement and asked the Sherwin-Williams High Performance Flooring team to provide recommendations on the best solution. The concrete substrate needed significant repairs, as it had not been fully replaced since the company's inception in 1986. After the substrate was repaired, the team got to work on applying coatings.

Surface preparation of the substrate included mechanically profiling the floor to remove all surface contaminants and laitance, achieving a concrete surface profile (CSP) of 4-6, which indicates a heavy to medium blast. After the floor was inspected for other imperfections, the primer was applied and cured for one hour to the appropriate tackiness.

The mortar blend was mixed and immediately applied to the substrate using skilled power troweling – a method unique to this type of epoxy mortar – followed by a Sherwin-Williams 3746 grout. Because of the conditions that the substrate would endure, a Sherwin-Williams 4638 polyurethane enamel was applied as a topcoat. Its properties make it resistant to a wide range of chemical, weather and mechanical conditions.

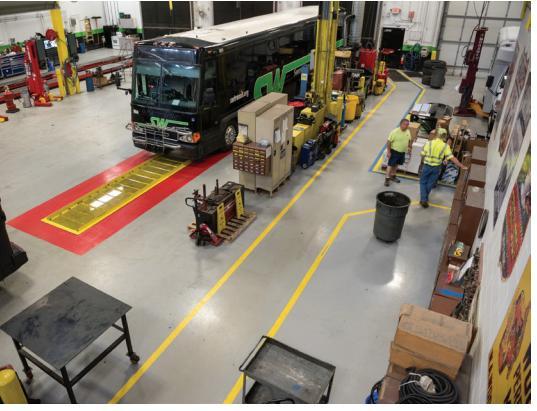
AFTER

Today, the facility continues to withstand the constant bus traffic, chemicals associated with heavy automobile maintenance, and the harsh elements of a Minnesota climate without worrying about floor damage.
